# MONUMENT RECORD

Corner ID: **CICr\_W23**

**Center 1/4 Corner**

Section 36- T07N-R01W, 2nd P.M.

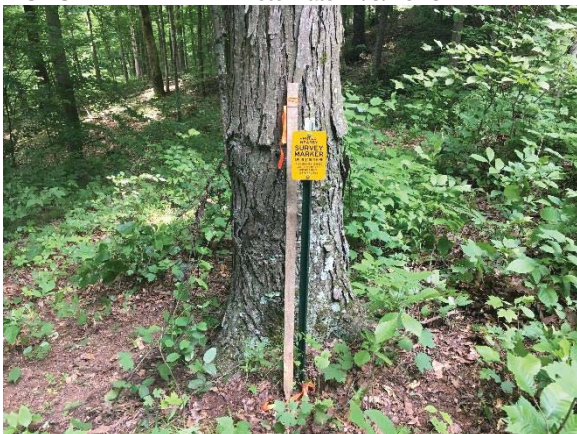
**MONUMENT:** Describe monument set or found (Include material type, scribing, distance above/below grade, dimensions.)  
3/4" galvanized iron pipe found 0.3' above grade.

Photo Orientation & Description: Looking SW at CICr\_W23

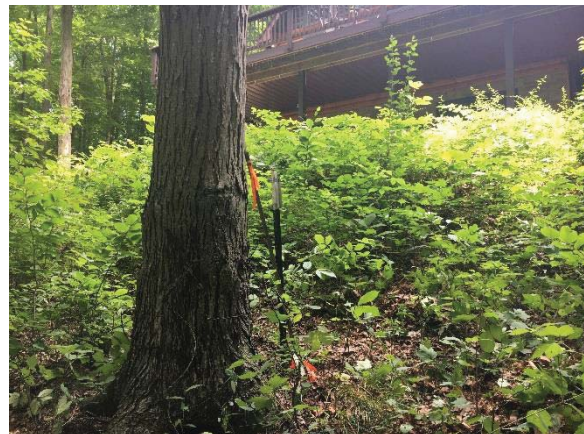
Photo Orientation & Description: Looking north at CICr\_W23
